ASH CREEK ESTUARY

Master Plan

Ash Creek Conservation Association, Inc.

ASH CREEK CONSERVATION ASSOCIATION, INC. • DECEMBER 2012

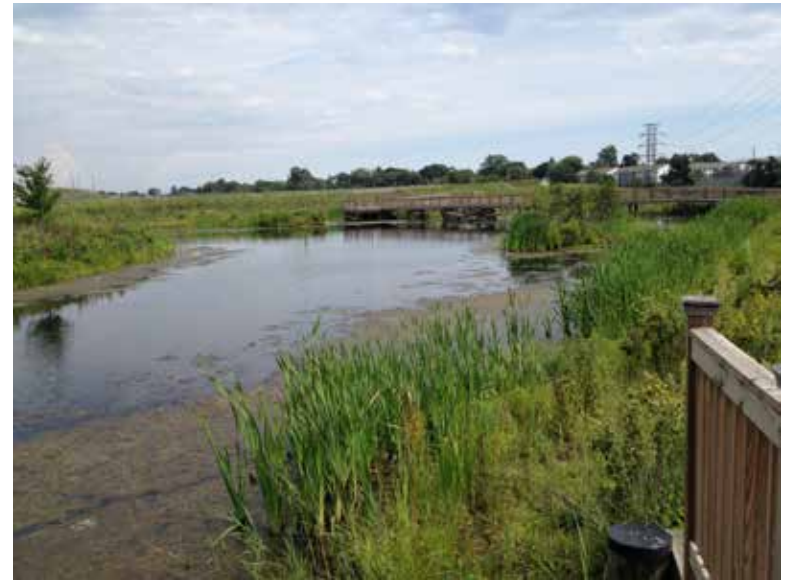
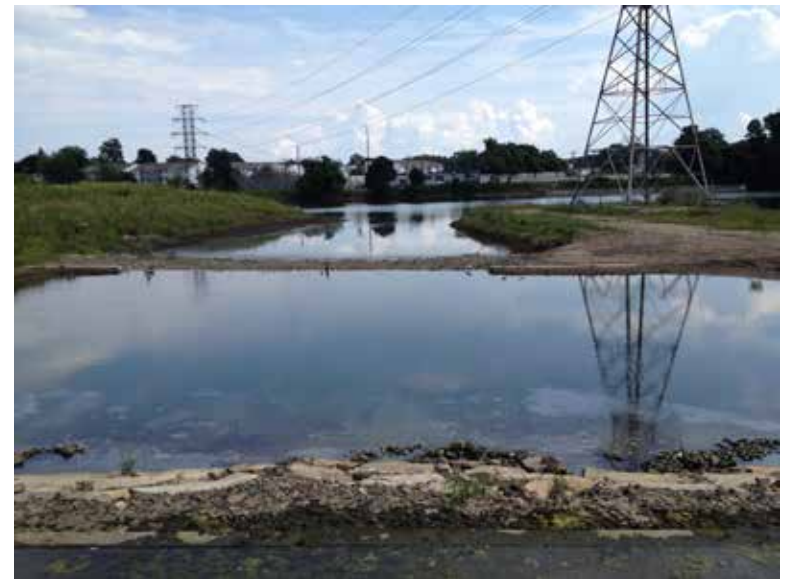
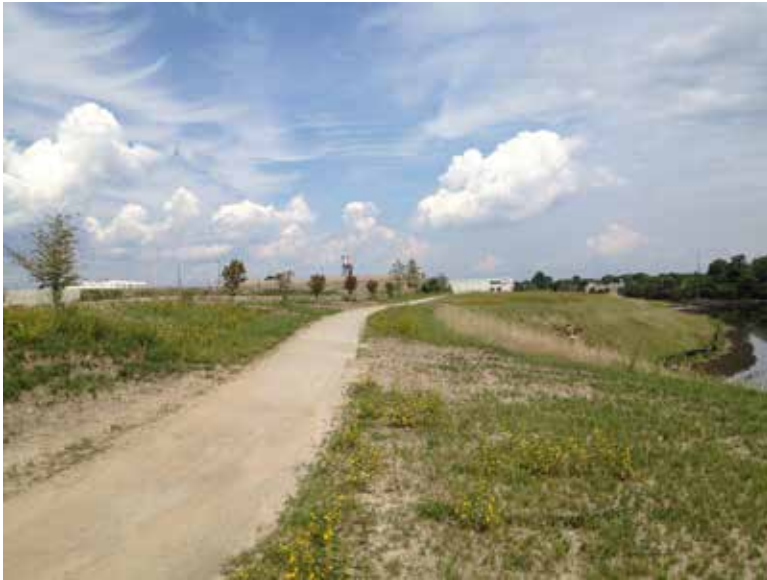
There was also a demonstrative lack of tidal wetland vegetation colonizing the 2800 foot length of the newly created bank to the creek below the Metro Center. The banks appear to be of a grade sufficient to support high and low marsh species, and the substrate has been stabilized with coir netting and stakes. According to the set of restoration plans reviewed at the Town of Fairfield, there appears to be no intent by the project managers to actively vegetate the lower tidal interface of the bank with the creek with *Spartina* plugs, or any other type of tidal wetland vegetation. As a result, it is assumed that this area is supposed to re-vegetate through local seed sources. As of now, it appears that this has not been accomplished. It should be noted that natural re-vegetation usually works best when the topography is gentle enough to prevent wave action and current scouring from disturbing newly seeded areas before they have a

chance to establish. In the case of the Upper Creek, mid to high level flow velocities through the area may preclude the ability of such a natural seedbed to become established.

It is unclear at this time if the 2600 foot long mitigation project will meet its project goals – as noted in the above section, at the time of the investigation it appeared that the substrate for a fringe marsh was created and stabilized with coir and erosion netting, however, there did not appear to be any substantial discernable level of *Spartina* occupying the newly created landform.

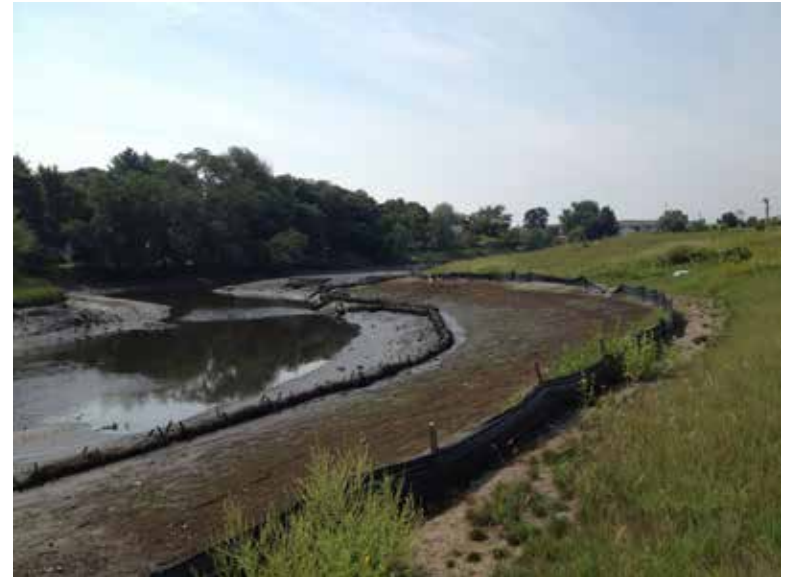
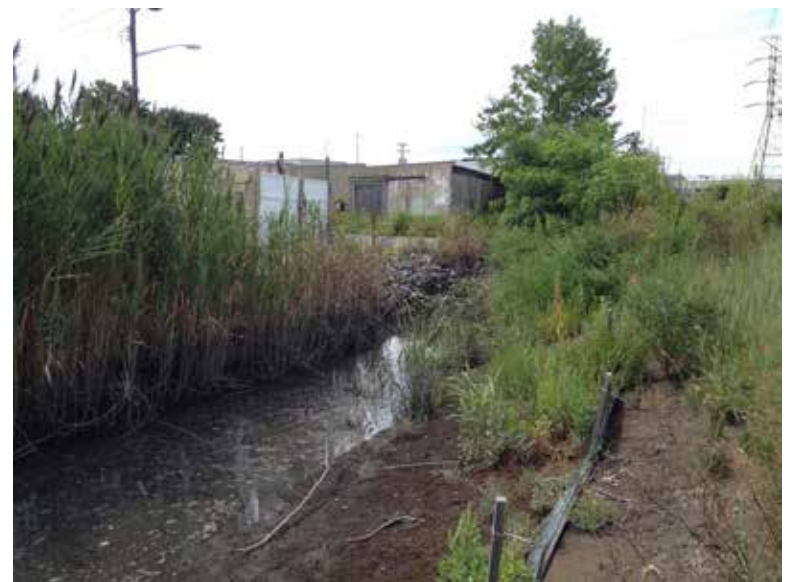
Low amounts of high marsh

There is relatively little native high marsh vegetation left in this area. Much of this is due to Phragmites colonization, human disturbances, and a general lack of available topographic habitat which in turn may be due to former manipulations of the banks of the waterway.

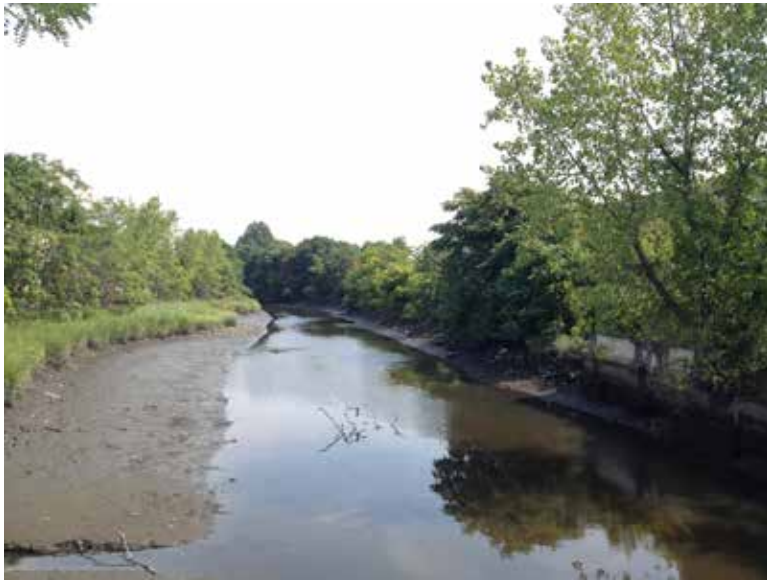
Success of the Metro Center mitigation high marsh wetland fringe

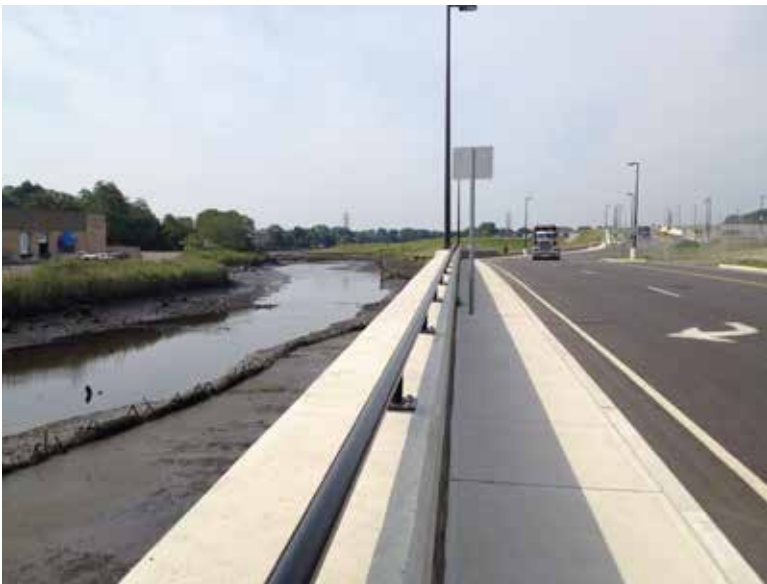
Proposed bridge crossing

There has been discussion on the municipal level regarding a potential pedestrian bridge to be erected across the channel. The Greater Bridgeport Regional Council has recently issued an RFP for a feasibility study. To date of this report, nothing has been proposed, however, it is our understanding that the designers are looking at the Fox Street area for the crossing. If such a crossing is implemented, it could be combined with aquatic habitat creation. It should be noted that the current electric line crossing involves a small free standing island for the footings of one of the towers. This island has developed habitat value over time due to its vegetative cover of shrubs and trees. Any future placement of support structures for a proposed bridge within the channel could likewise represent an opportunity for aquatic or island habitat creation.

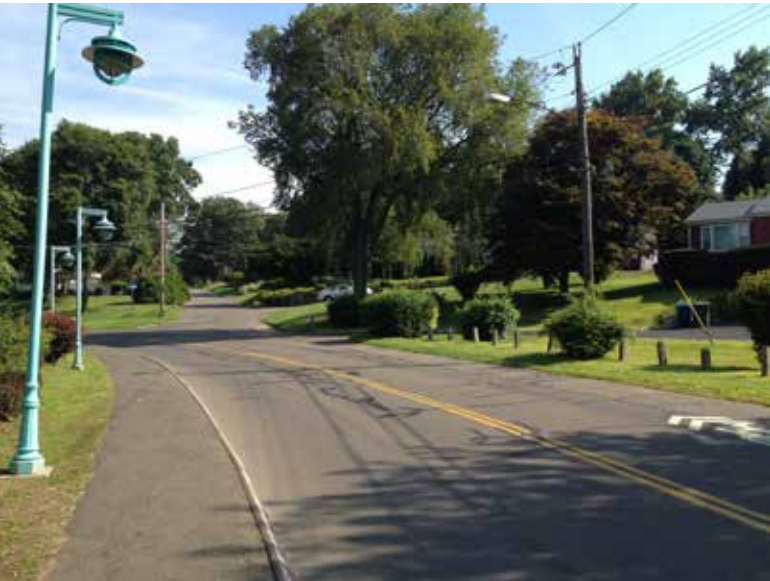
Buffer condition on east side

In many areas the buffer to the tidal creek on the east side is in poor condition due to inadequate widths. The available area is constrained by the road. Furthermore, the soils on the slope below the road are compacted in many areas, leading to reduced permeability and hydraulic conductivity. This discourages the establishment of vegetation, and discourages pollutant attenuation, leading to water quality impacts to the creek.

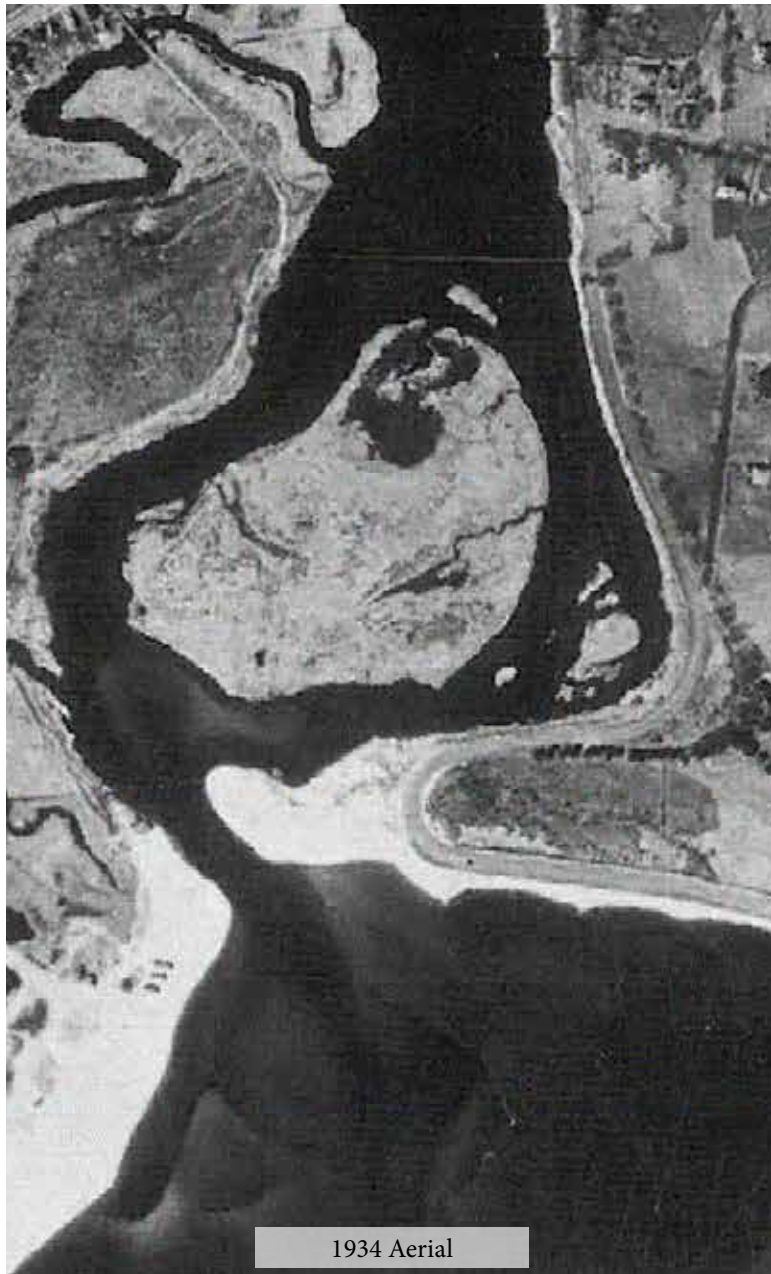
1934 Aerial

The edge of the sand spit has aggraded and degraded over the years according to the influence of human activities on vegetation and by the channel maintenance. It is unknown if beach nourishment activities have taken place on Jennings Beach, or how frequently the channel is dredged. Deep waters created by dredging activities make this location a popular fishing area.

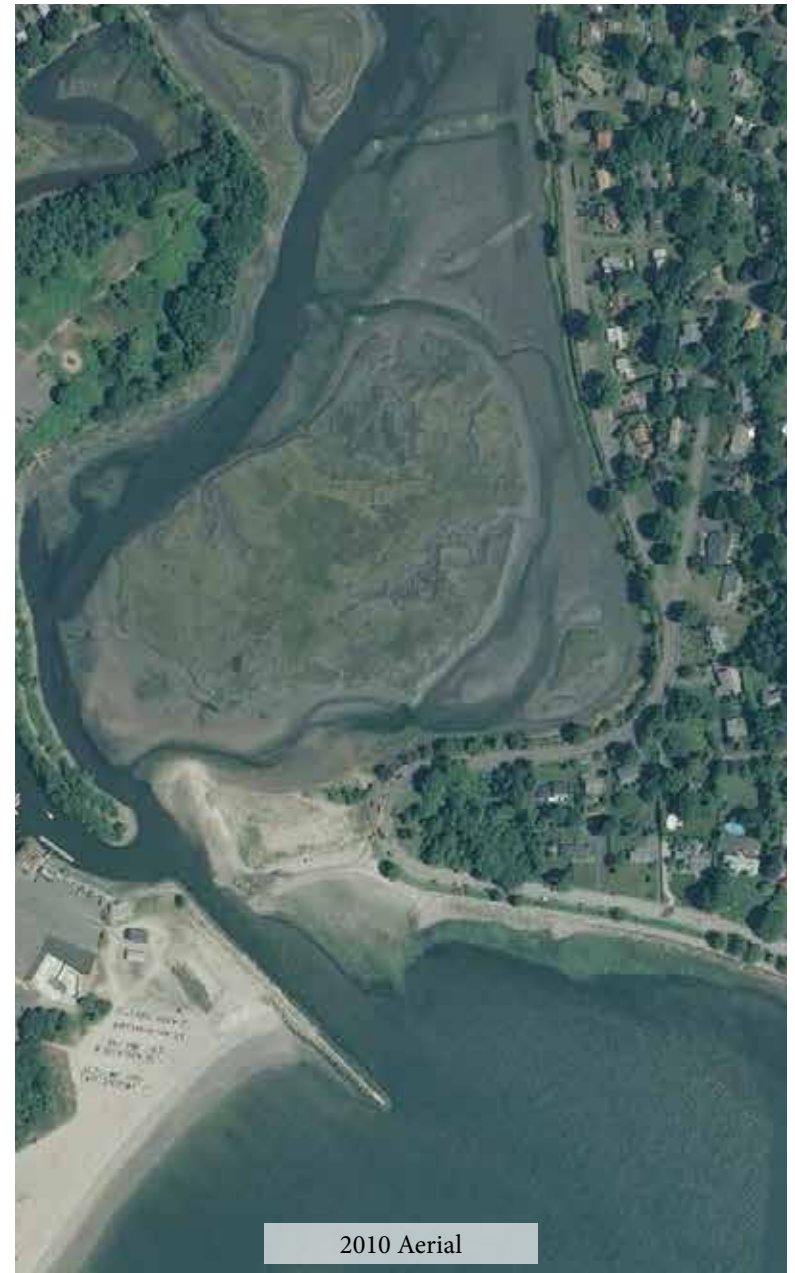
2010 Aerial

Historic dredging activities and the development of South Benson Marina have had a disturbance impact on the great marsh island since channel deepening causes stronger currents with erosive ripple effects on adjacent landforms. Dredging activities appear

to have also required mobilization of heavy equipment on the barrier spit, which has resulted in damaged habitat.
