Ash Creek Beach Enhancement

Date: October 17, 2011

SCOPE OF INVESTIGATION

At the request of Ash Creek Conservation Association (ACCA) a review of the plan prepared by the City of Bridgeport for the Ash Creek Beach Enhancement Project was conducted.

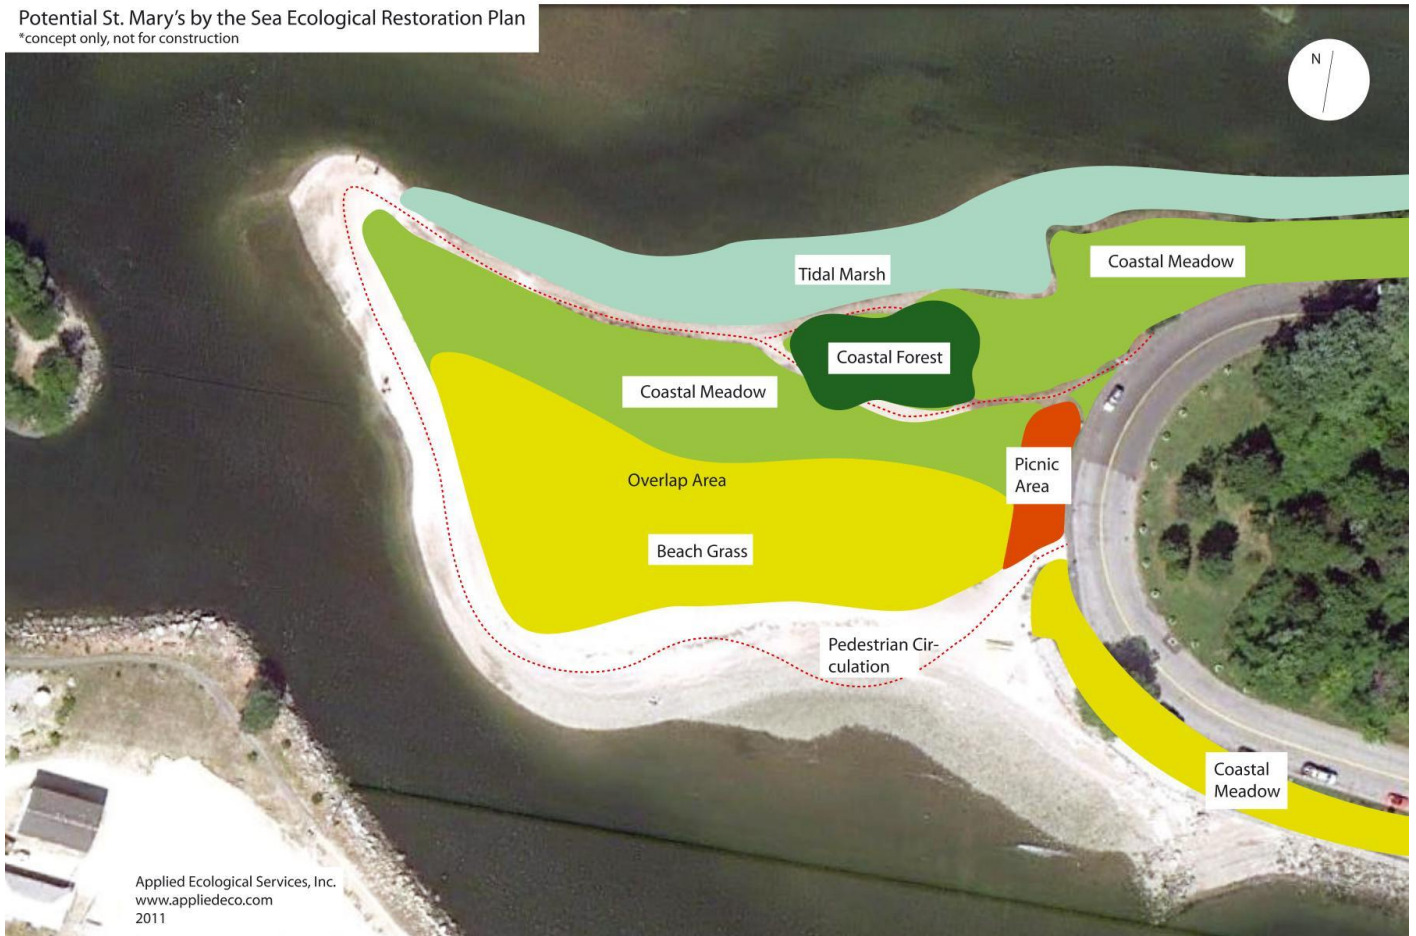
APPENDIX I

Potential St. Mary's by the Sea Ecological Restoration Plan
*concept only, not for construction

The following pages offer enhancements to that plan that we believe will strongly improve the current restoration project. We also offer a restoration concept master plan in the form of a graphic, intended to stimulate thinking and discussion between stakeholders about what could be done with the site in the future.

From a holistic perspective, these options collectively constitute an overall ecological master plan for the site, which can be implemented over time. The implementation of these recommendations will allow public use, improve local ecology, provide neighborhood beautification, and allow the site to serve as an educational resource to the community.

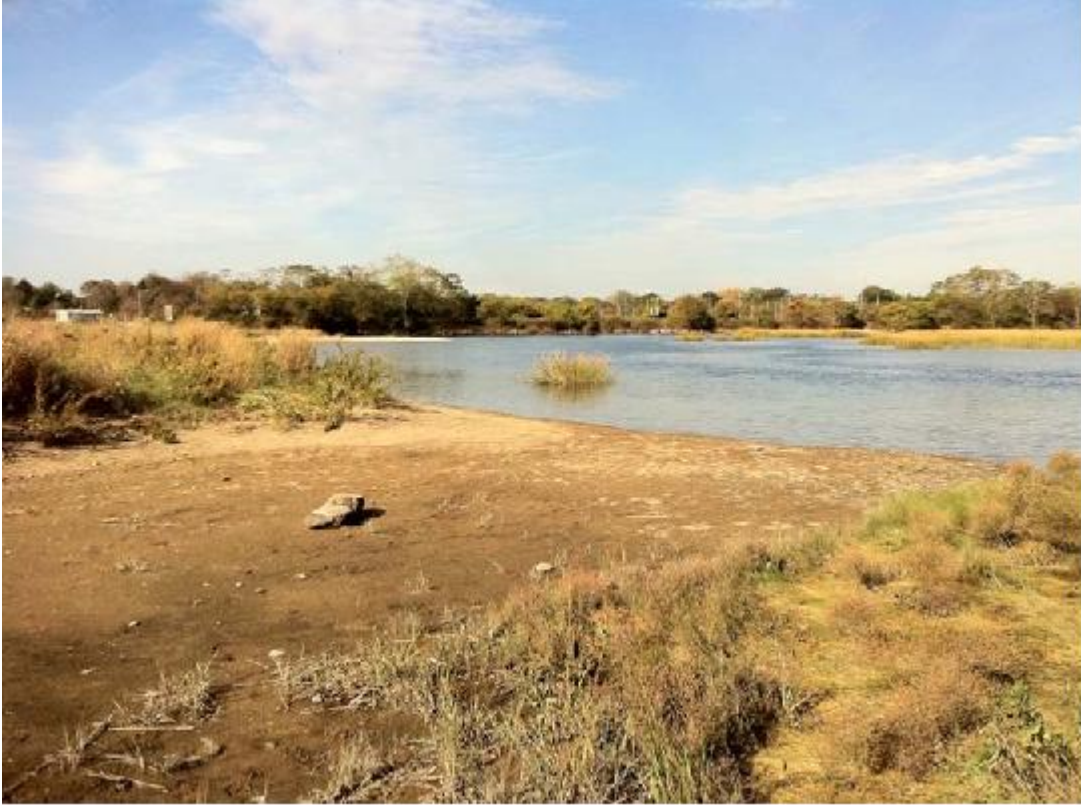
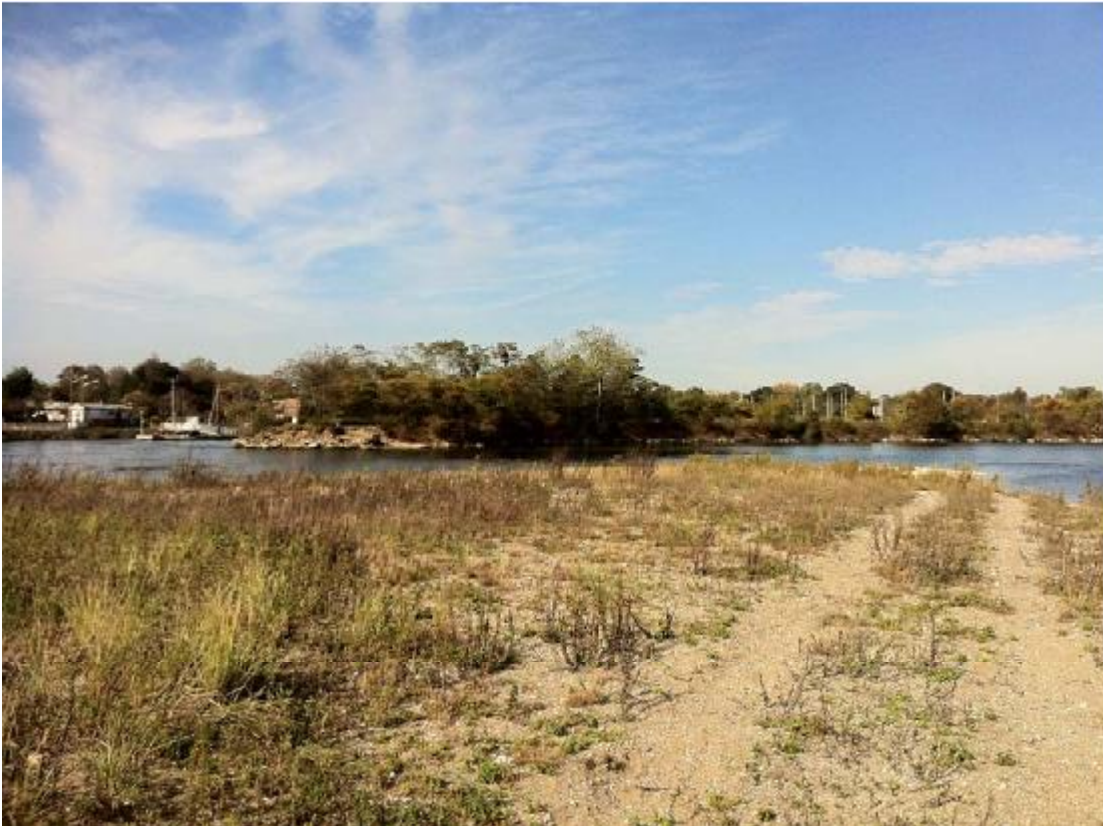
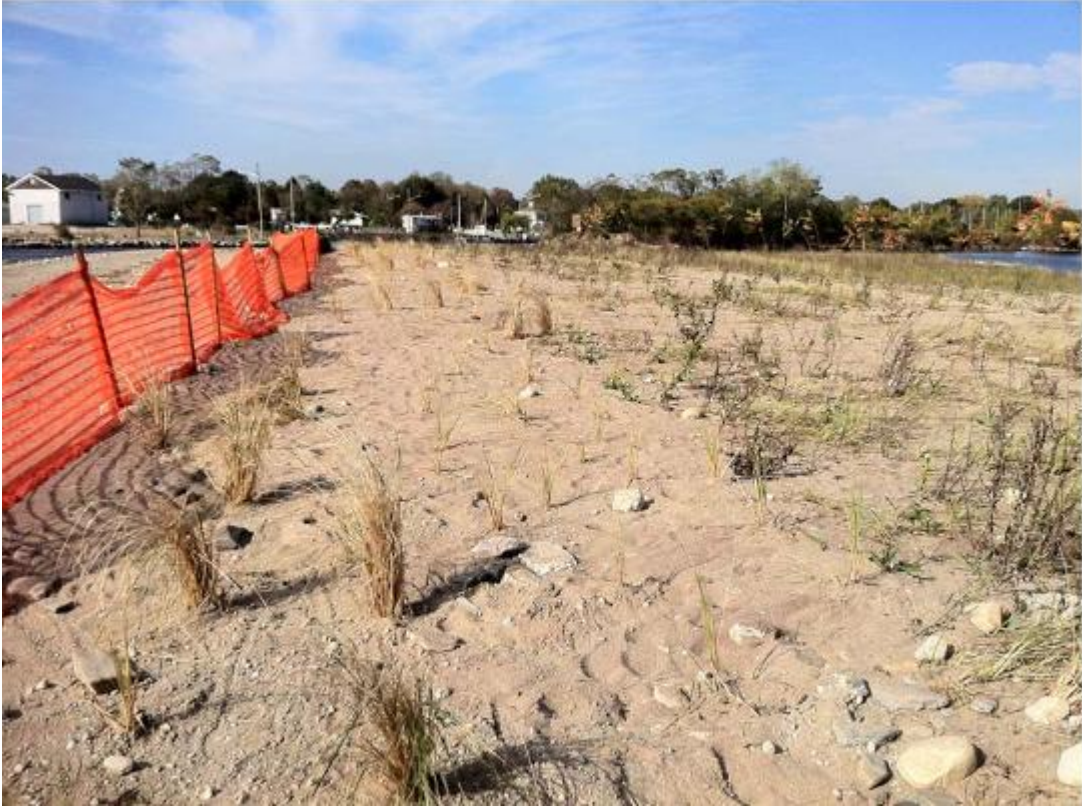
Appendix II

Three photos of the site taken on 10/11/2011
